TEST REPORT PZ-Hoch-200665

for the proof of Fire behaviour according to DIN 4102, part 1

perforated self-adhesive PVC-film in a nominal thickness of about 145µ

"PanoRama Innova ICE"

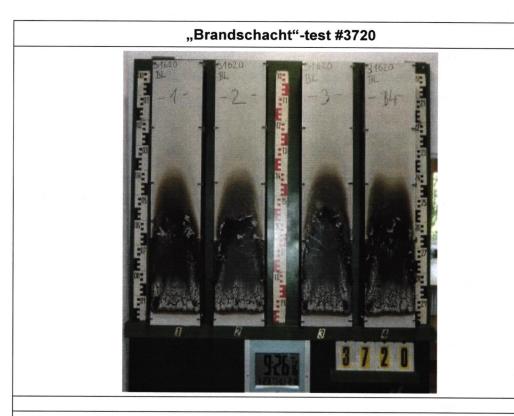
measurement #3720, PN31620: CONTINENTAL, "PanoRama Innova ICE" Max. flue temperature: 104°C, Smoke density integral: 1%min Residual length: 49 cm 200 100 Flue gas temperature [°C] Light attenuation [%] 150 100 50 0 0 2 8 Test duration 10 min
